Symptom	Probable Cause	Action
PDC hand does not move on startup - Display Reads "PDC Not available , Please Check Cables" The status lights on the PDC controller does not turn on  The status light is flashing Amber only or Flashing Green Only	1. Monetary Device is defective 2. MDB Cable not connected 3. Incompatible VMC / PDC software 4. Incompatible PDC Hardware / Software 5. Blown fuse. 6. Defective Ribbon Cable 7. Defective Igus 8. Hardware does not function	Disconnect coin mechanism , Bill Validator or Card reader from the VMC and check to Connect the MDB Cable. <a href="#">Check Compatibility chart</a> <a href="#">New boards / New firmware (2.XX) is not compatible with older boards / older firmware (1.XX)</a> <a href="#">Check the fuse - System Diagram ( SXY / Vue )</a> <a href="#">Check the light status on the PDC - replace Ribbon Cable if there are no lights on the PDC Board</a> <a href="#">Check the continuity on the IGUS cable wires - Click for wiring diagram</a> Replace PDC controller

**Model: Vue 30 / 40**

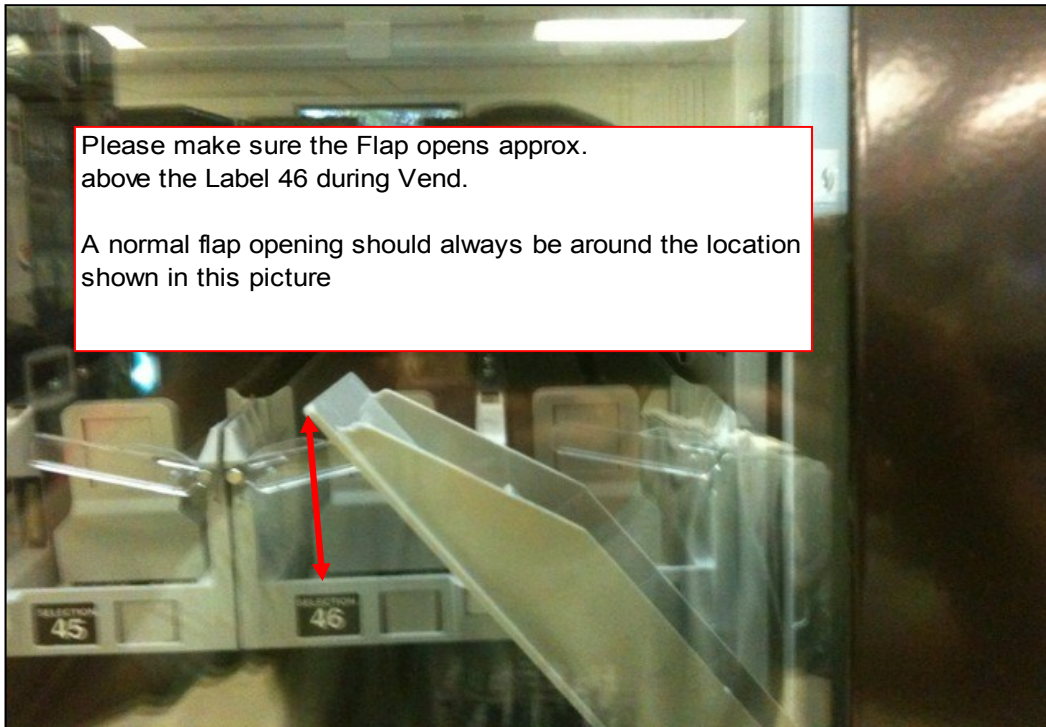
Please make sure the Flap opens approx.  
above the Label 46 during Vend.

A normal flap opening should always be around the location  
shown in this picture

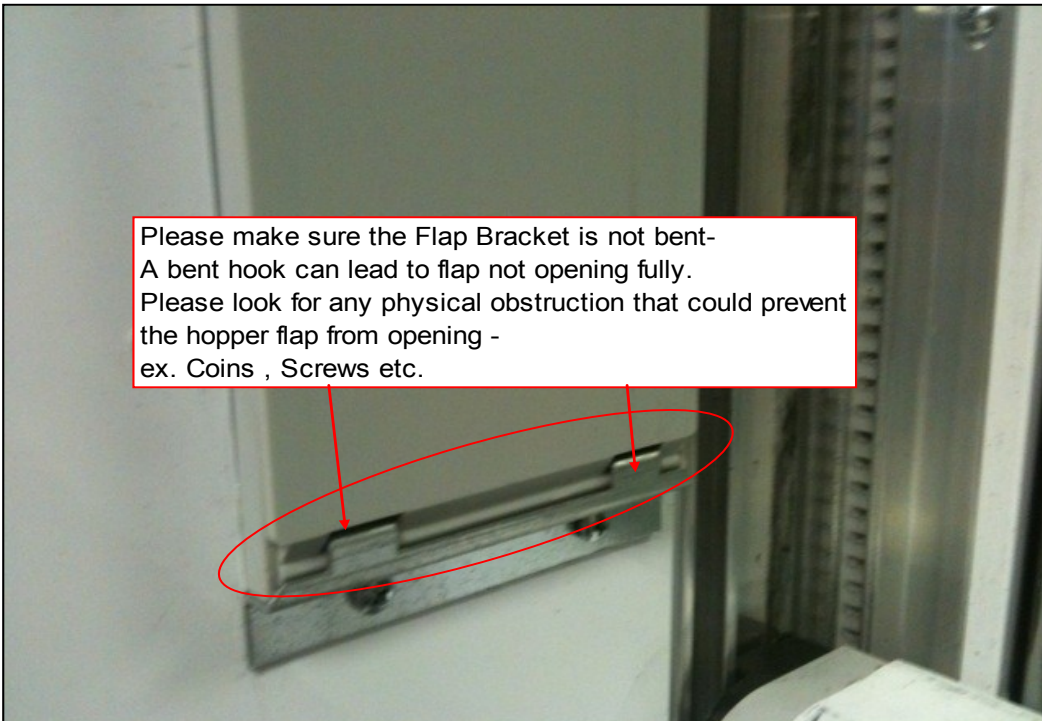
Please make sure the Flap Bracket is not bent-  
A bent hook can lead to flap not opening fully.  
Please look for any physical obstruction that could prevent  
the hopper flap from opening -  
ex. Coins , Screws etc.

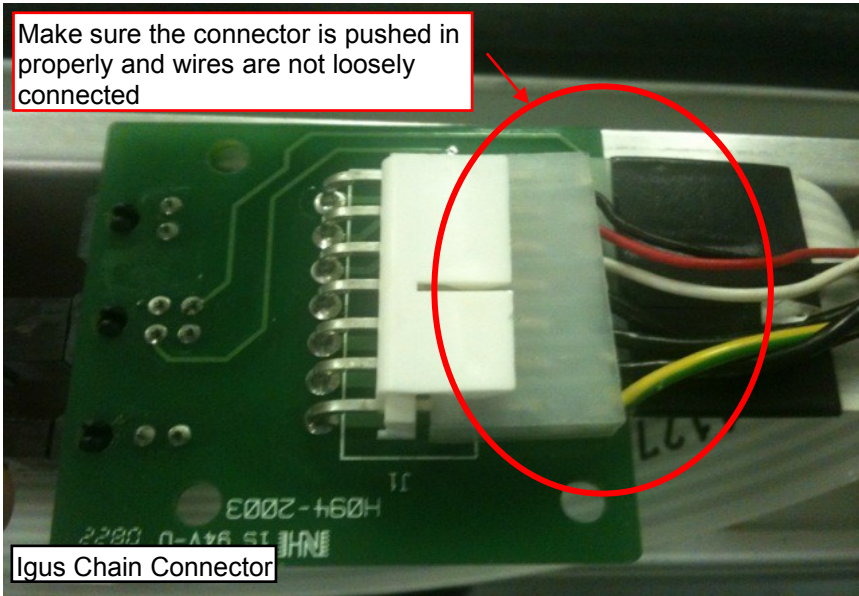
Igus Chain Connector

Make sure the connector is pushed in properly and wires are not loosely connected
